737 GRAPHITE COMPOSITE FLIGHT SPOILER FLIGHT SERVICE EVALUATION

THIRD ANNUAL REPORT
APRIL 1976 THROUGH APRIL 1977

1. Report No. NASA CR-145207	2. Government Accession No.	3. Recipient's Catalog No.	
4. Title and Subtitle 737 GRAPHITE COMPOSITE FLIGHT SPOILER FLIGHT SERVICE EVALUATION		5. Report Date August 1977

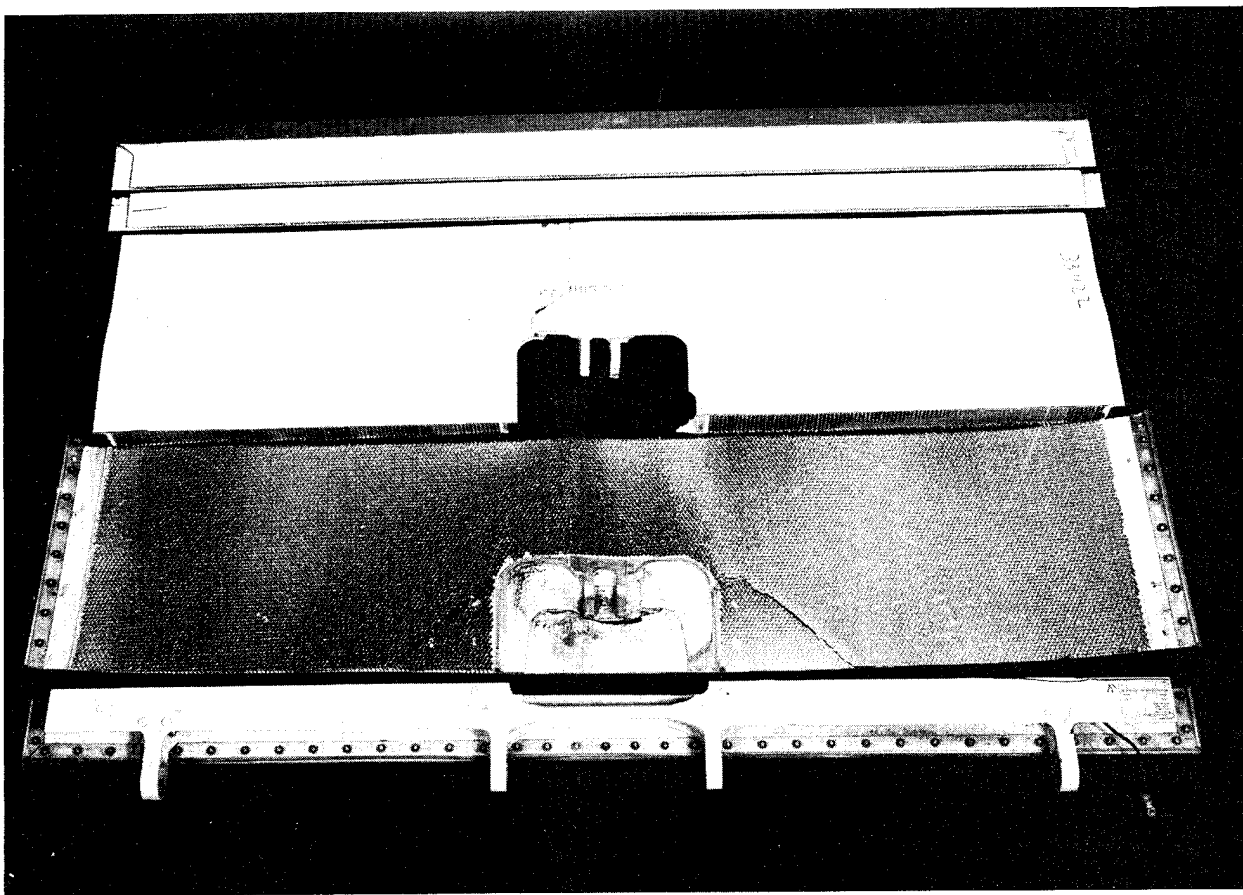
The examination technique for honeycomb core corrosion has been expanded to encompass all units that are tested in the static test laboratory. Each spoiler assembly is completely sectioned to enable visual observation of both bond lines in virtually all portions of the panel. Figure 4 shows a typical example of the degree of dissection achieved. A total of five static test spoilers (S/N 0057 and 0109 from the second year testing and S/N 0026, 0054, and 0116 from the third year testing) have been sectioned in this manner. Not only has there been a complete absence of corrosion in the honeycomb, but the physical appearance of both the honeycomb and the cured EA9628 adhesive compares favorably with newly manufactured assemblies.

Figure 4. — Dissection of S/N 0054 for Corrosion Inspection

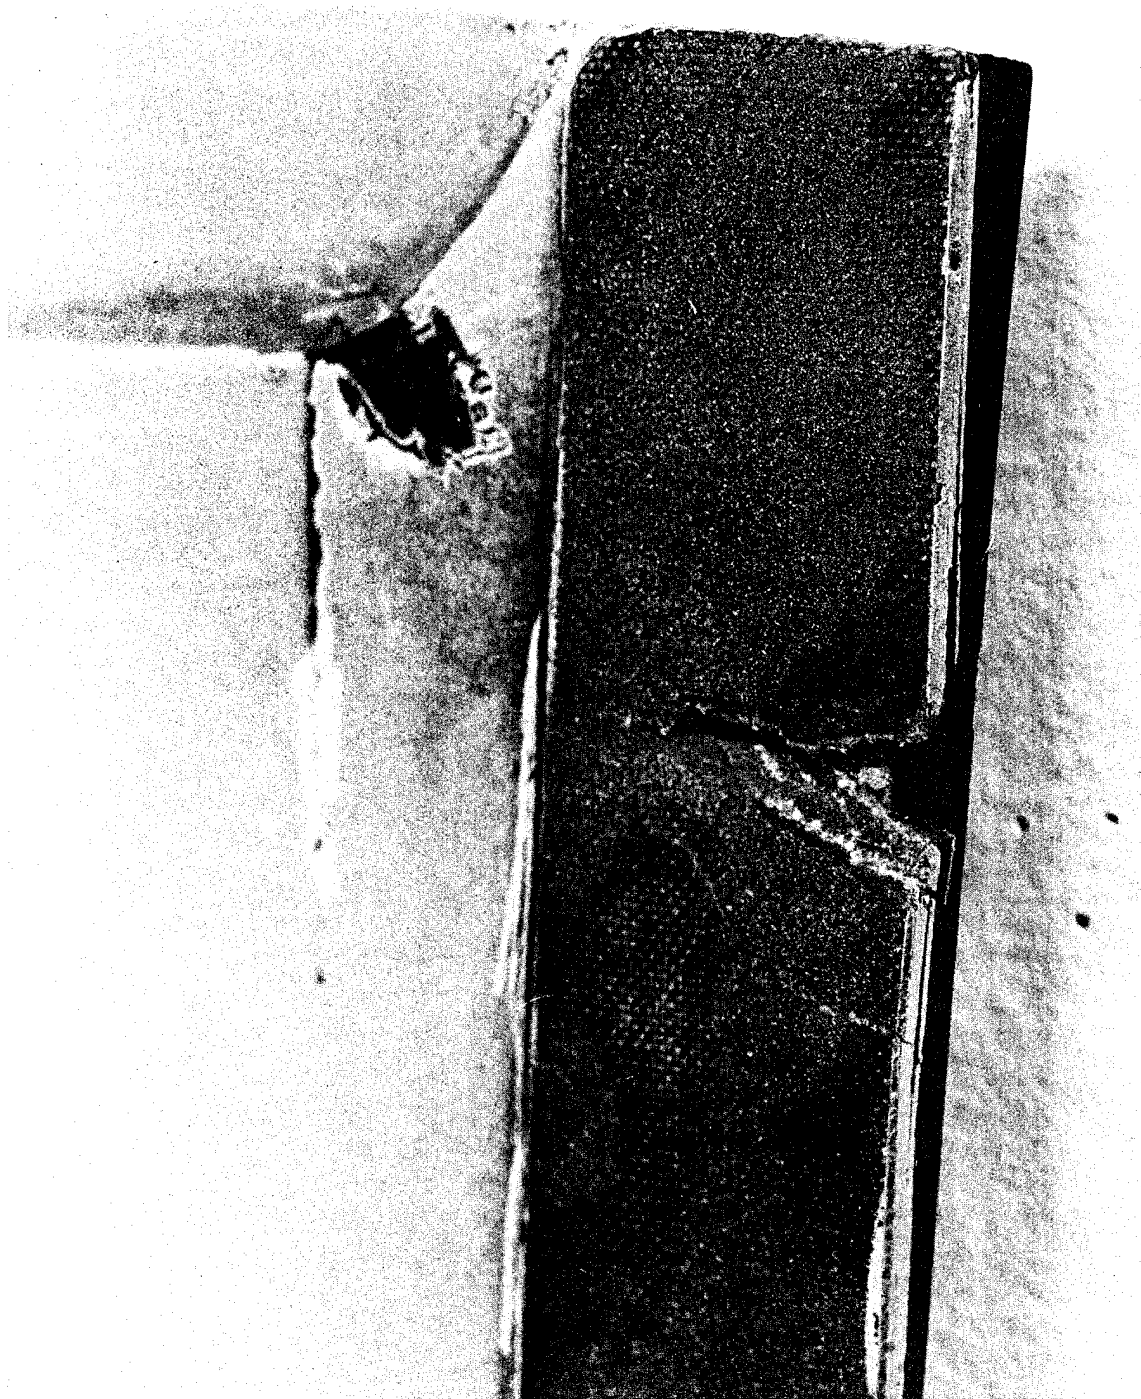
The three cases of maintenance damage are illustrative of the ever-present risks associated with maintenance operations. Each instance of maintenance damage occurred inside the maintenance hanger area and was a result of activity involving aircraft components in the vicinity of the spoilers themselves. Two incidents resulted in damage to the trailing edge (figs. 7 and 8) and one panel received handling damage to the leading edge spar (fig. 9). The rate of maintenance damage approximates that of the previous year of operation.

Figure 7. — Trailing Edge Damage — S/N 0089

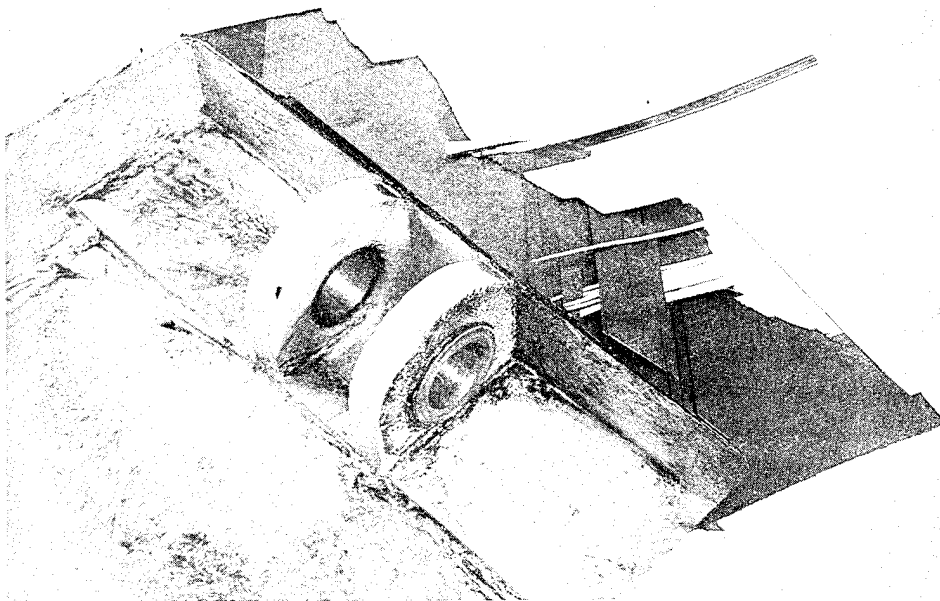
The initial introduction of the all-composite spoiler into flight service occurred on December 18, 1975, by Aloha Airlines. (ref. 1). Subsequent installations of two assemblies each were made by National Airways (NZ), Lufthansa, Piedmont, and Frontier Airlines. On August 6, 1976, Aloha Airlines reported a lower surface skin delamination on spoiler S/N 0306 (fig. 10) following a routine overnight inspection. No structural failure reports were filed prior to the routine inspection and subsequent removal from service. A similar examination of spoiler S/N 0307 showed similar, though less severe, evidence of delamination and strain. A precautionary examination by the remaining operators was conducted, and all remaining spoilers were removed from service to preclude any potential risks for the operators. All units have been returned to Boeing pending a decision on disposition.

Figure 10. — Lower Surface Delamination—Aloha Spoiler S/N 0306
